The fire in your ATV

Stalls/Misses/Sputters during Light Throttle:

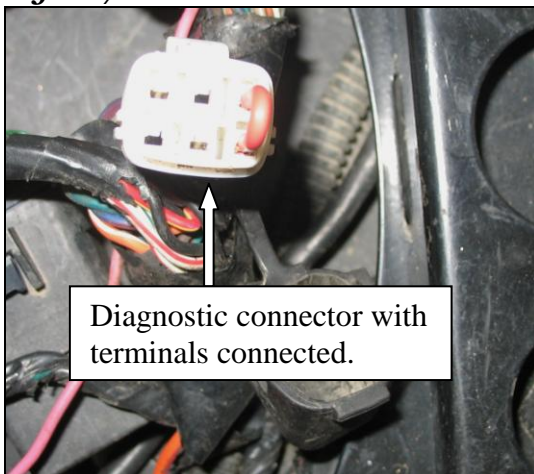
Figure 7:

- 1) Re-install the factory ECU.
- 2) Find the diagnostic connector near the ECU (it is usually white, with a black dust cap). It will have six (6) positions, but only four (4) positions will have wires inserted. Connect the two terminals together with a piece of wire or a paper clip. See Figure 7.
- 3) Turn on the key, and observe the speedometer pod. The display will show “-Coo” or “-Eoo” (depending on your machine). If the dash is centered on the C or E, then it is adjusted properly. If it is either high or low on the C or E, then you’ll need to adjust the TPS. See Figure 9.
